# TrueNAS<sup>®</sup> M-Series NVDIMM Updates

v. 24051

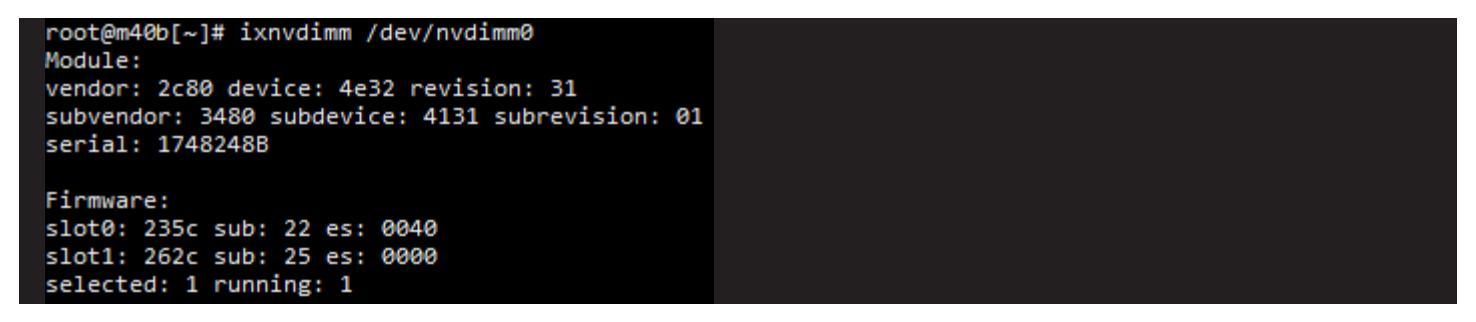
Enter ixnvdimm /dev/nvdimm0 . Make sure that firmware slot 1 is selected and running.

Enter ixnvdimm /dev/nvdimm0 |grep -o "slot1: [0-9A-F][0-9A-F]".

The two digits after slot1: indicate the firmware version. For example, a 22 indicates version 2.2. The latest firmware version is 2.6.

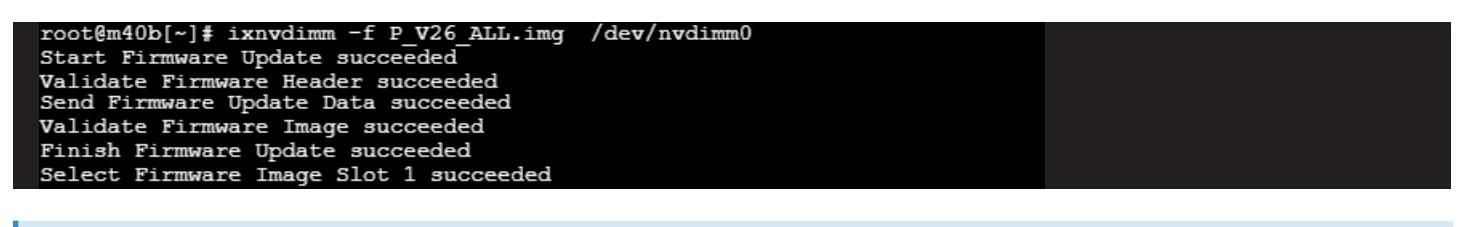
Enter ixnvdimm -f P\_V26\_All.img /dev/nvdimm0 where P\_V26\_All.img is the downloaded firmware update file.

The `Validate Firmware Image` step can take up to 30 minutes. If it fails, rerun the command.
